Manhole Inspection Summary

Manhole # S25YY_076MH

Insp Date: **7/11/08 10:02 AM**

Location Address: **3300 CLIPPER RD**

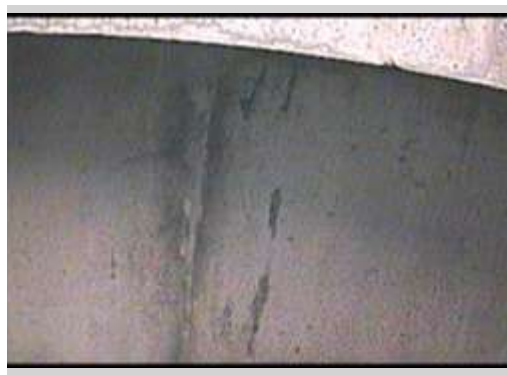
Defect

Frame leaks. Adjustment, Corbel and Barrel infiltration.

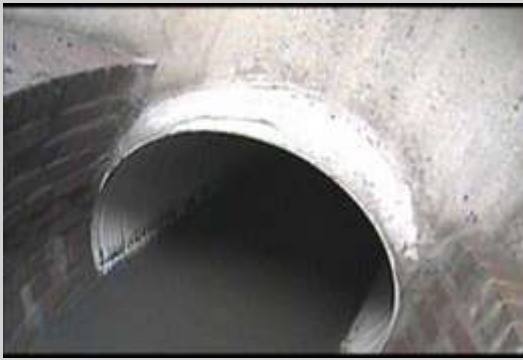
36 in. Circular Gravity Sewer Pipe Out @ 12 O'Clock

Pipe Material: **Unknown** ☒ Pipe Lined

Invert Depth: **11.40** (ft.) Flow Characteristics: **Fast**

Infiltration: **None** Pipe Seal Cond: **Unknown**

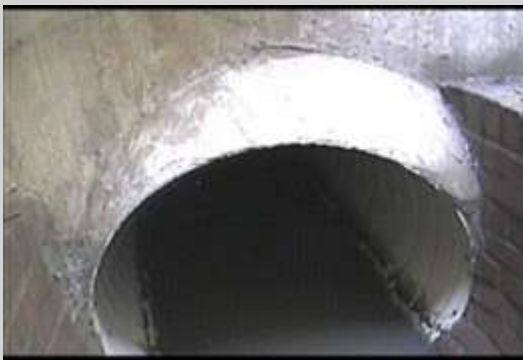
36 in. Circular Gravity Sewer Pipe In @ 5 O'Clock

Pipe Material: **Unknown** ☒ Pipe Lined

Invert Depth: **11.01** (ft.) Flow Characteristics: **Fast**

Infiltration: **None** Pipe Seal Cond: **Unknown**
